**A to Z Inspection Services**

**Inspected By: A To Z Inspection Services Chad Verville**

Prepared For: Sean Litherland

Inspected On Fri, Aug 1, 2025 at 10:00 AM

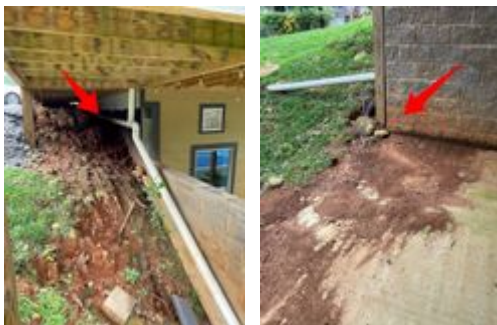
Example pic; Recommend creating a positive drainage slope throughout perimeter to divert water away from the foundation and prevent erosion.

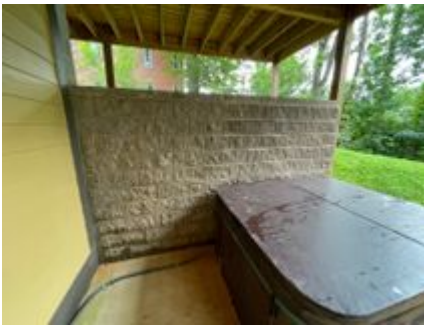
Example pic; Recommend trimming vegetation away from contact with house throughout as needed.

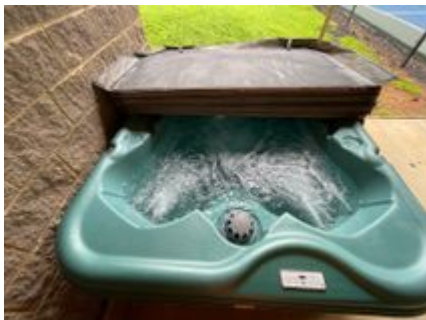
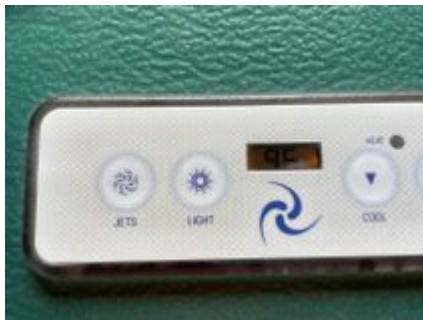
Hot tub was functional at time of inspection. Hot tub cover shows some damage.

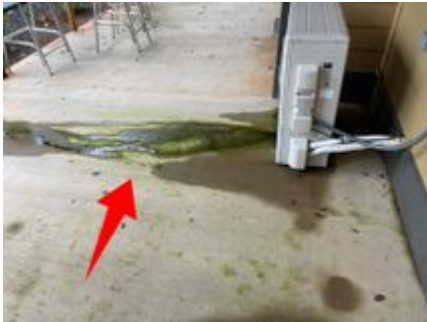
HVAC unit is condensating onto patio. This is a trip / slip hazard, use with caution.

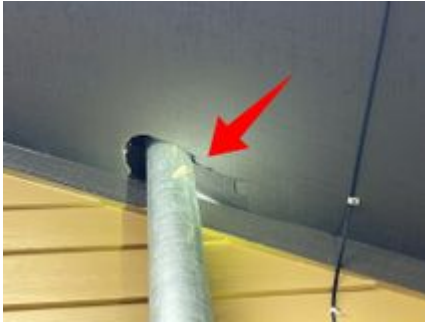
Soffit is damaged and unsealed at electrical mast.

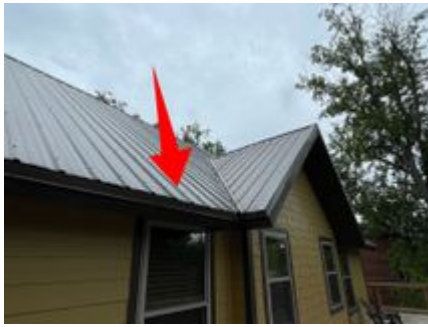
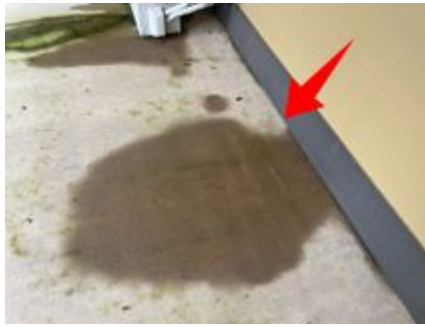
No gutters present at upper level deck roof. Guttering installation recommended to prevent moisture intrusion and damage.

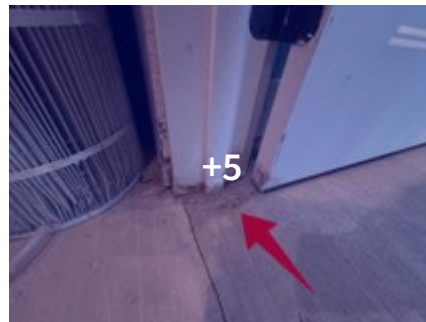
Moisture staining / efflorescence / organic growth observed within the basement.  
Recommend further evaluation and repair / remediation as needed.

\*\*\*Gutters appear to be overflowing and negative grading appears to be contributing to moisture.

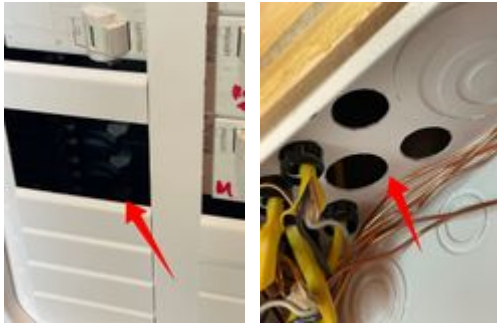
Recommend enclosing all open knockouts throughout as needed.

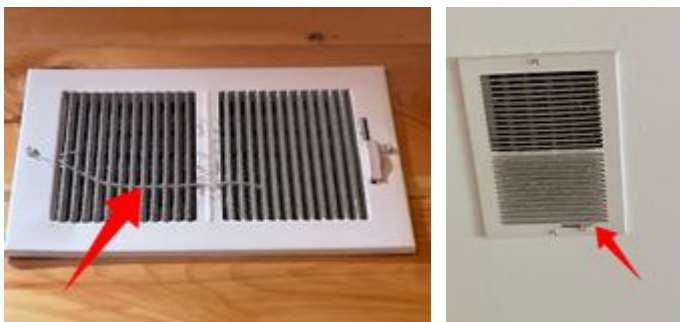
HVAC registers are dirty.

Recommend cleaning ductwork throughout as needed.

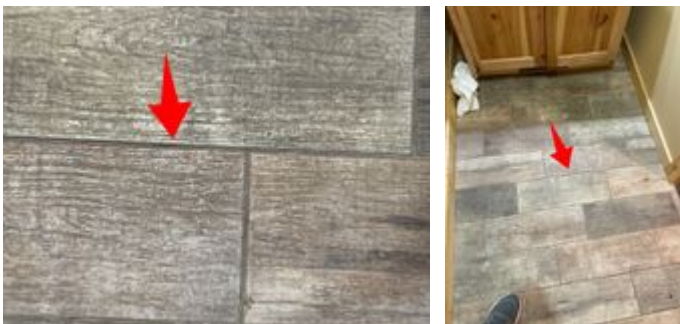
Floor tiles are loose and grout is missing in this area.

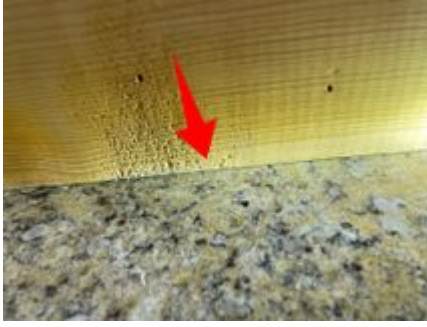
Recommend caulking / sealing countertop edges and backsplash as needed.

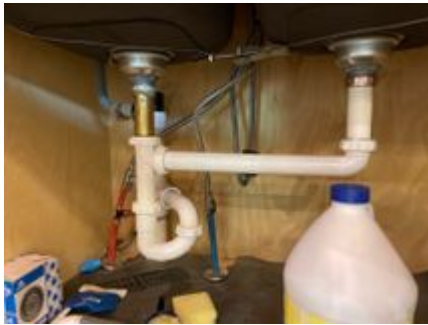
Dishwasher drain line did not perform a visible high loop to create a trap under sink.

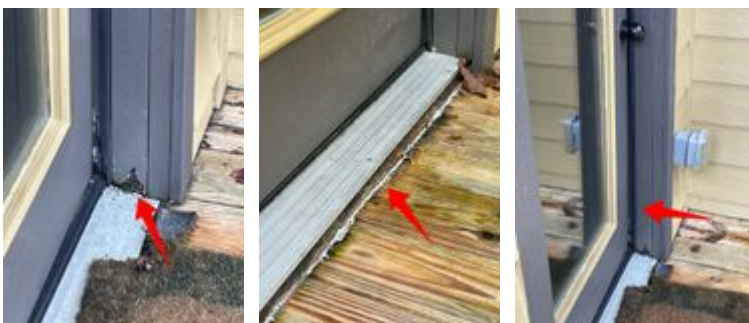
Deck entry doors show moisture damage at door frame and threshold, and door is bowing. Recommend further evaluation and repair / replacement as needed.

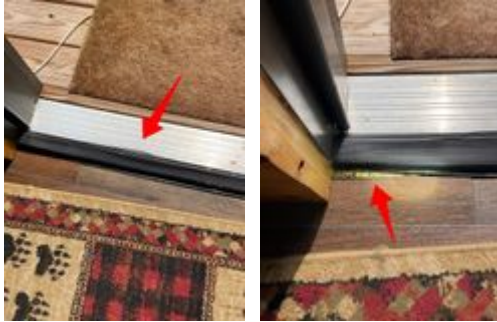
Rear deck entry threshold shows damage and gap at flooring.

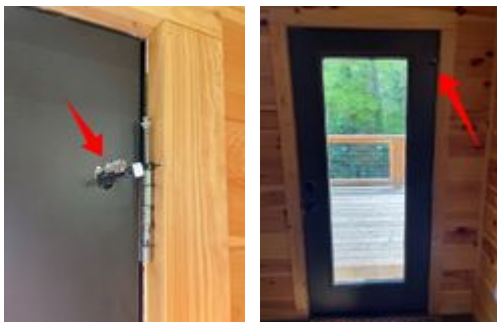
Doorstop has damaged door.

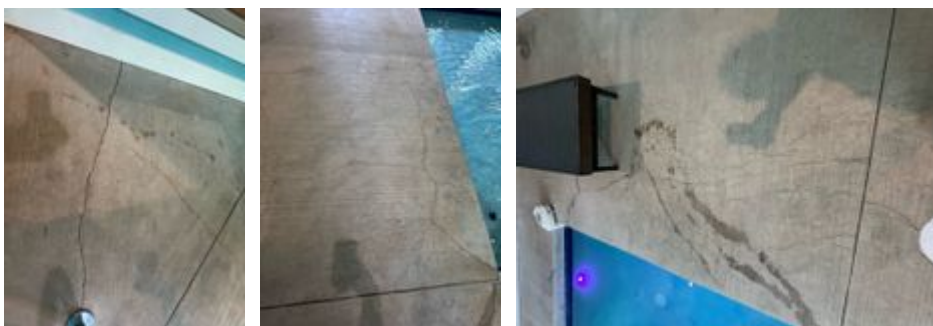
Pool decking shows settlement cracking.

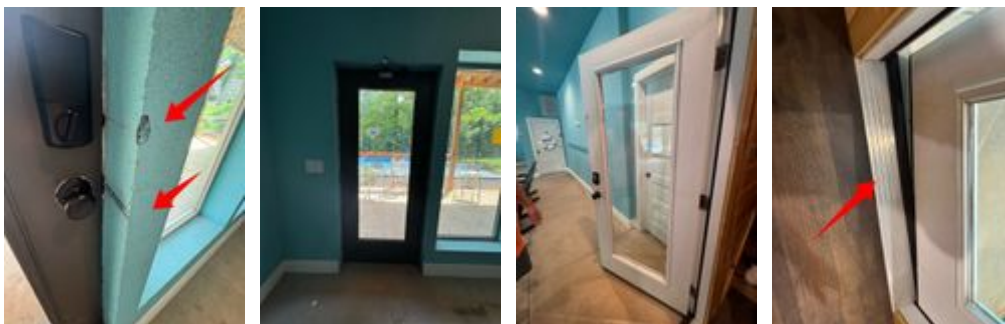
Doors need adjustment / repair to function properly. Wall shows damage

Recommend supporting / securing the loose threshold as needed.

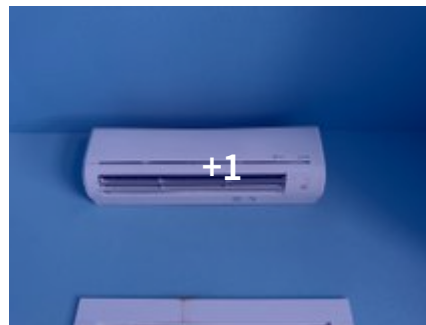
Pool room HVAC was functional at time of inspection. Recommend verifying with manufacturer for use within a wet location. This could cause premature deterioration / failure.

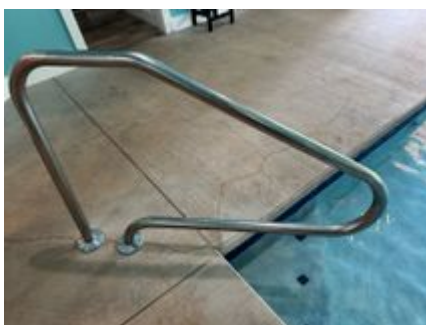
Recommend repair / supporting the leaning handrail.
