ACL Postoperative Imaging

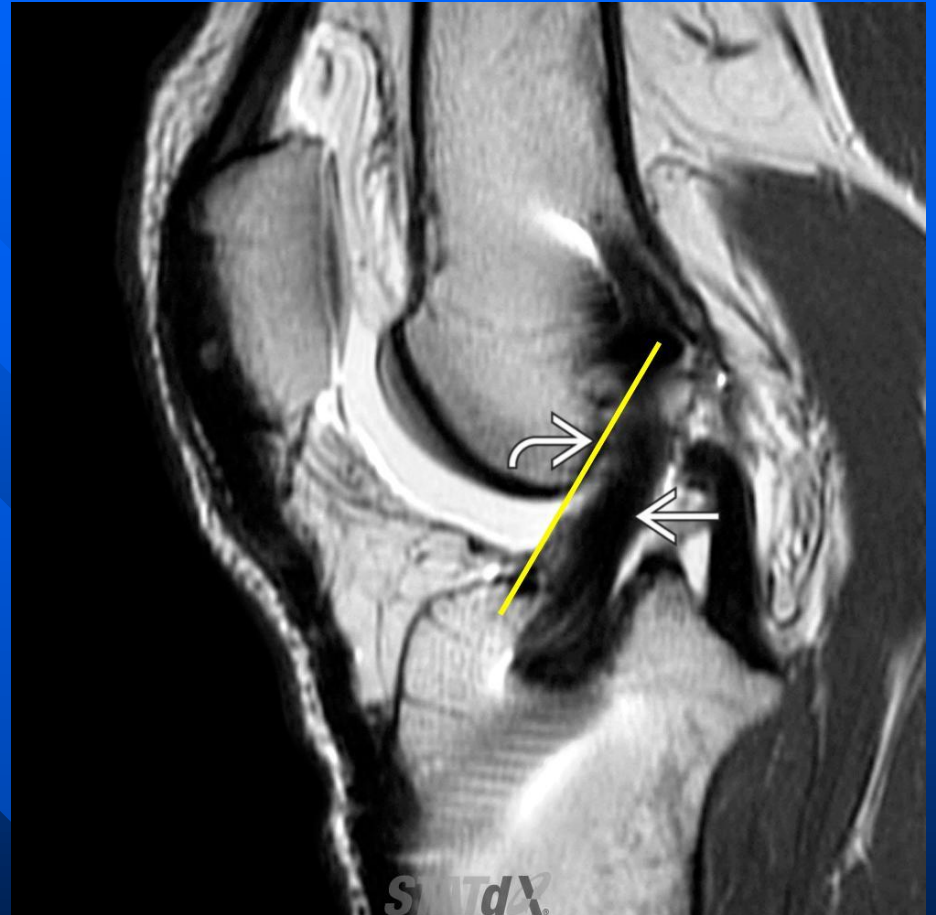
Normal Graft

- Correct placement of ACL tunnels resulting in ACL graft slope angle just behind Blumensaat line, the projection created by the angle of the roof of the intercondylar notch toward the tibia.

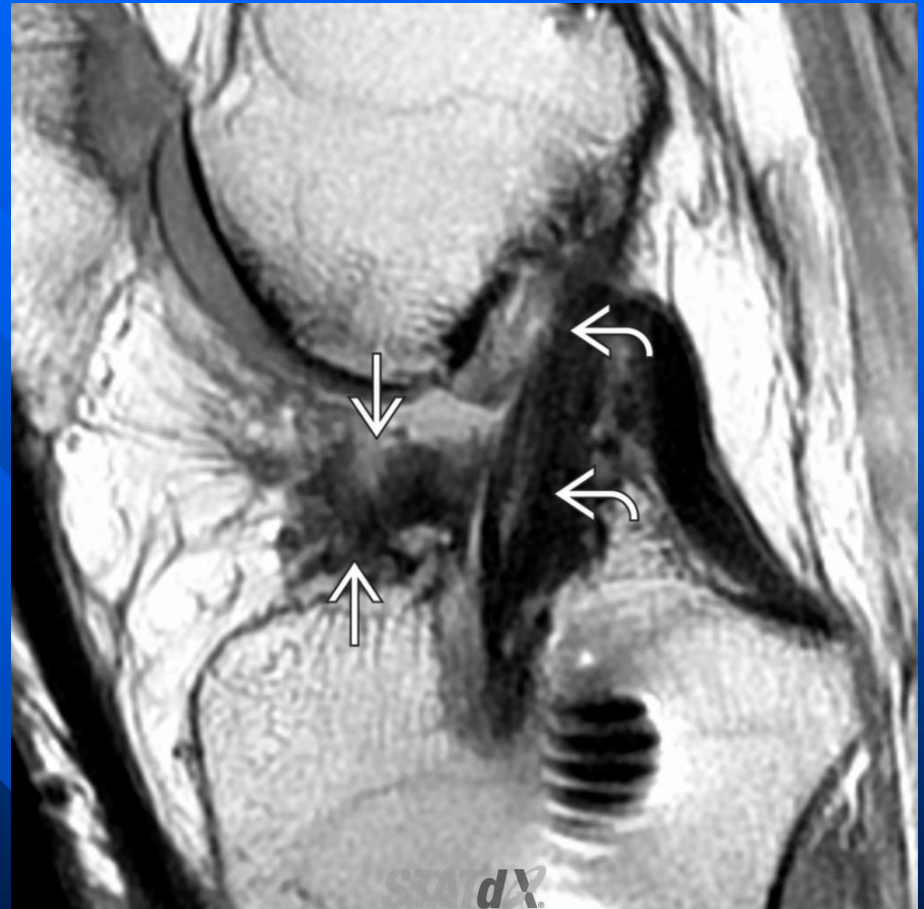
Anterior arthrofibrosis (cyclops lesion)

- Focal anterior arthrofibrosis (cyclops lesion) in a patient 1 year after ACL repair.
- The graft is separate from the lesion and is normal.
- The patient complained of pain and limited knee extension

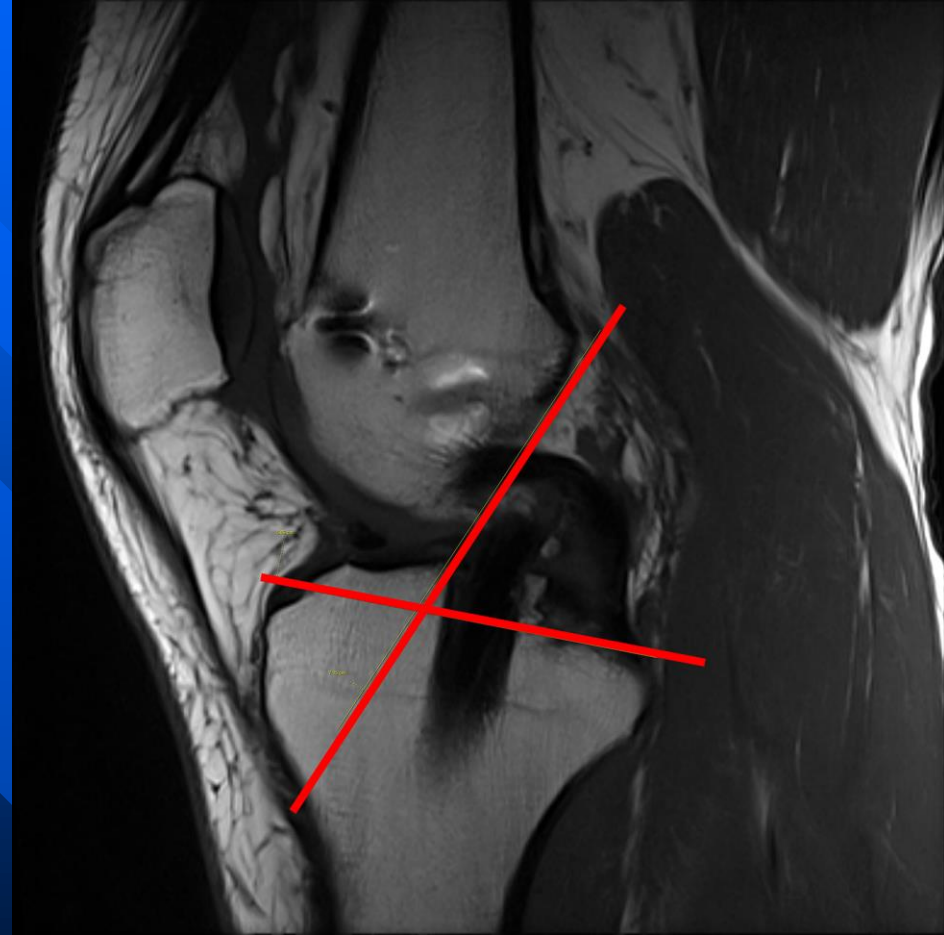
Blumensaat line

- Tibial tunnel is too far back and this is the main reason of joint instability.
- The oblique vertical red line represents **Blumensaat line**. The position of the tibial tunnel should be parallel but posterior to the slope of the Blumensaat line (intercondylar roof).

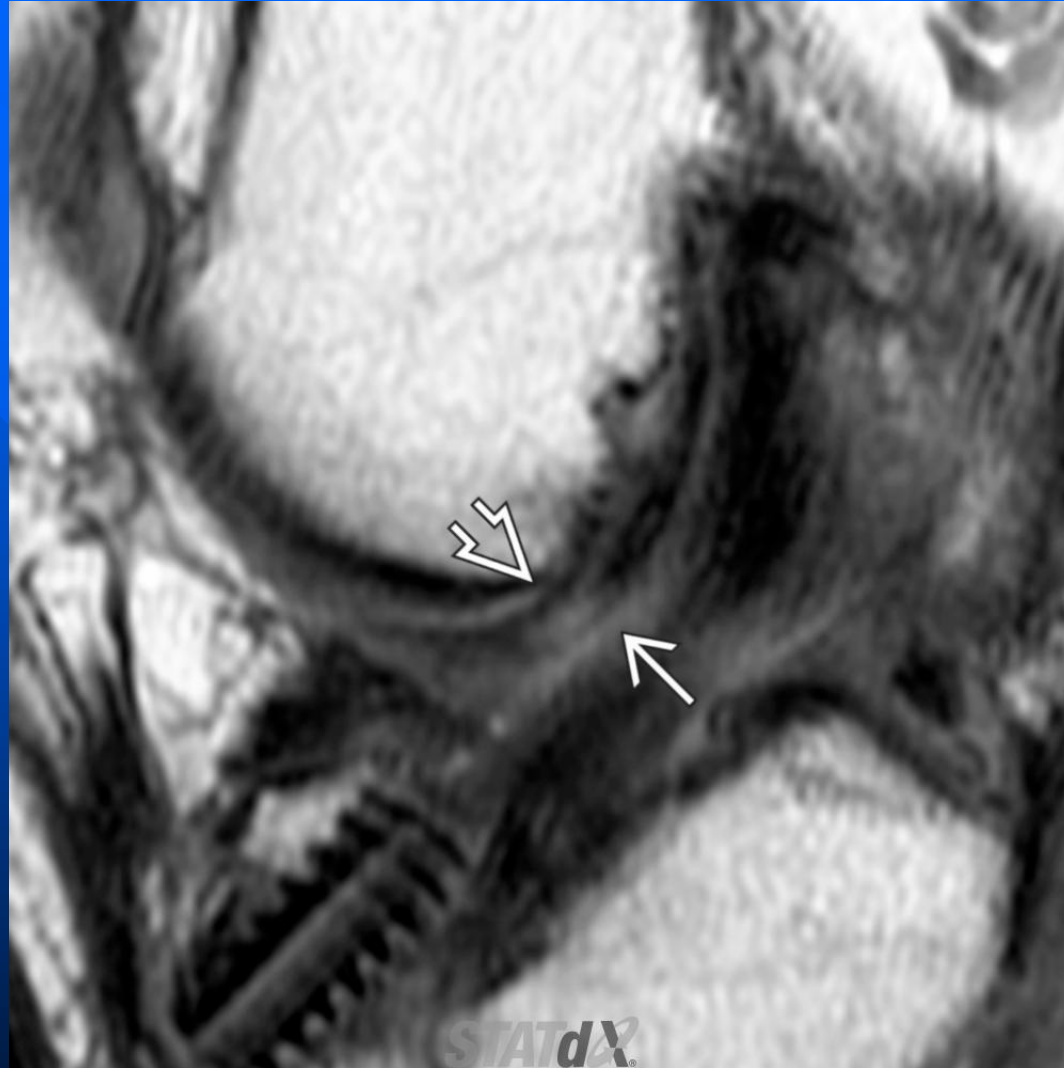
Roof impingement

Sagittal PDWI MR shows intercondylar notch roof impingement of an ACL graft. There is posterior bowing of the graft and relatively focal increased signal intensity (white solid arrow) at the point of contact with the notch roof (white open arrow).

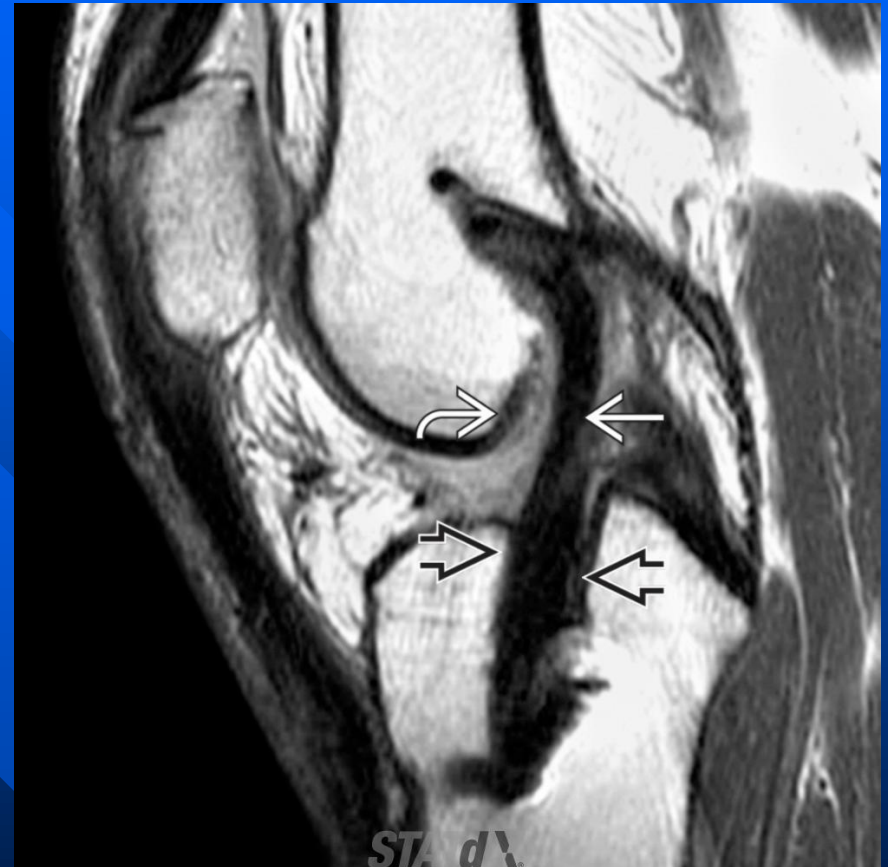
Posterior placement of tibial graft tunnel

- Resulting in vertical orientation of ACL graft . Note that the slope of the intercondylar notch roof projects a shallower angle.

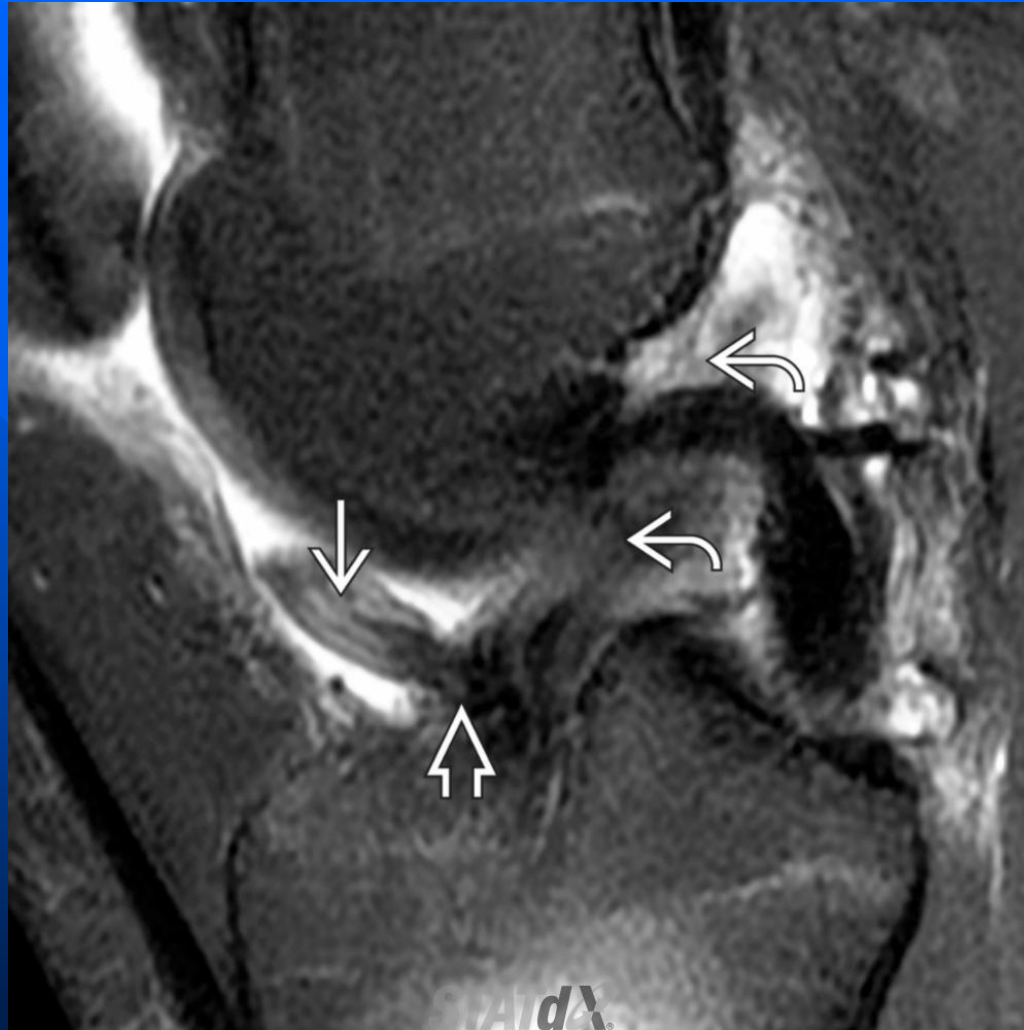
Entrapped ACL stump

Sagittal PDWIFS MR shows an intact ACL graft (white curved arrow) derived from hamstring elements. A well-defined linear focus of low signal (white solid arrow) is seen anterior to the graft with attachment to the anterior tibial spine (white open arrow). This is the entrapped stump of the native ACL.
