# Femoral Acetabular Impingement

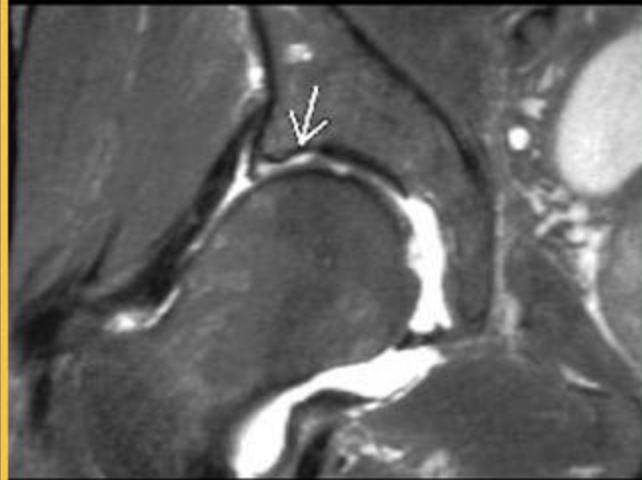
Coronal FS PD FSE MR shows femoroacetabular impingement with articular cartilage erosion (arrow) of the lateral margin of the acetabular roof. The acetabular labrum is torn.
