# Bankart-lesions

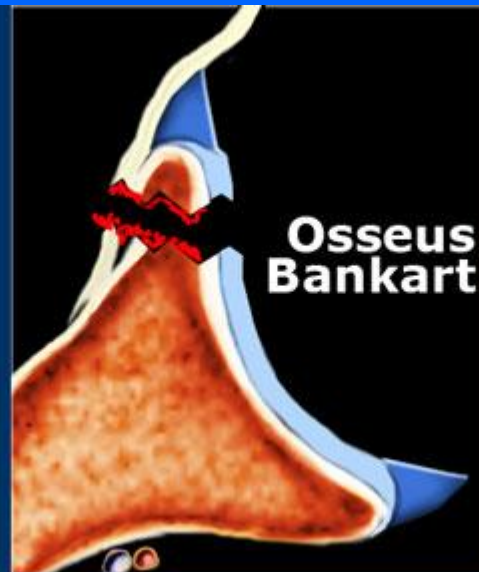
- Injuries to the anteroinferior labrum.
- These injuries are always located in the 3-6 o'clock position because they are caused by an anterior-inferior dislocation.
- The only exception to this rule is the reverse Bankart, which is the result of a posterior dislocation and injury to the inferoposterior labrum.
- Bankart tears may extend to superior, but this is uncommon.

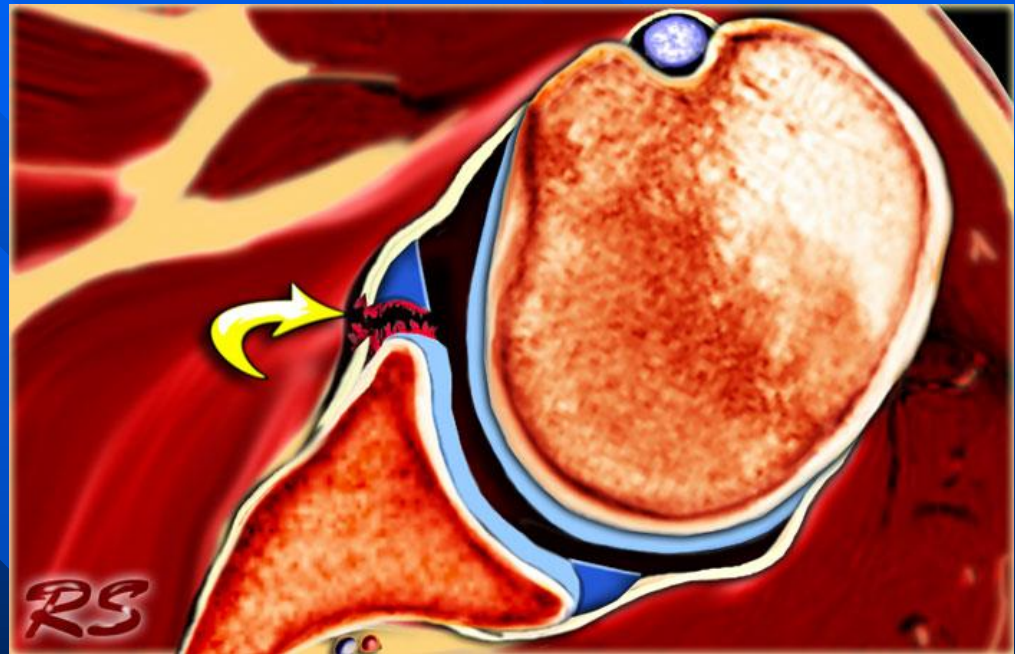
- Labral tears without an osseus fragment.
- MR arthrography or arthroscopy are optimal to diagnose Bankart or Bankart-like lesions.
- There is a detachment of the anteroinferior labrum (3-6 o'clock) with complete tearing of the anterior scapular periosteum.
- The arrow points to the disrupted periosteum.
